**WELL DECOMMISSIONING
ON THE LUMMI INDIAN RESERVATION
DURING 2010**

**Water Resources Division
Natural Resources Department
Lummi Indian Business Council**

**Andrew M. Ross, LG, LHG
Salix Environmental Services**

January 2011

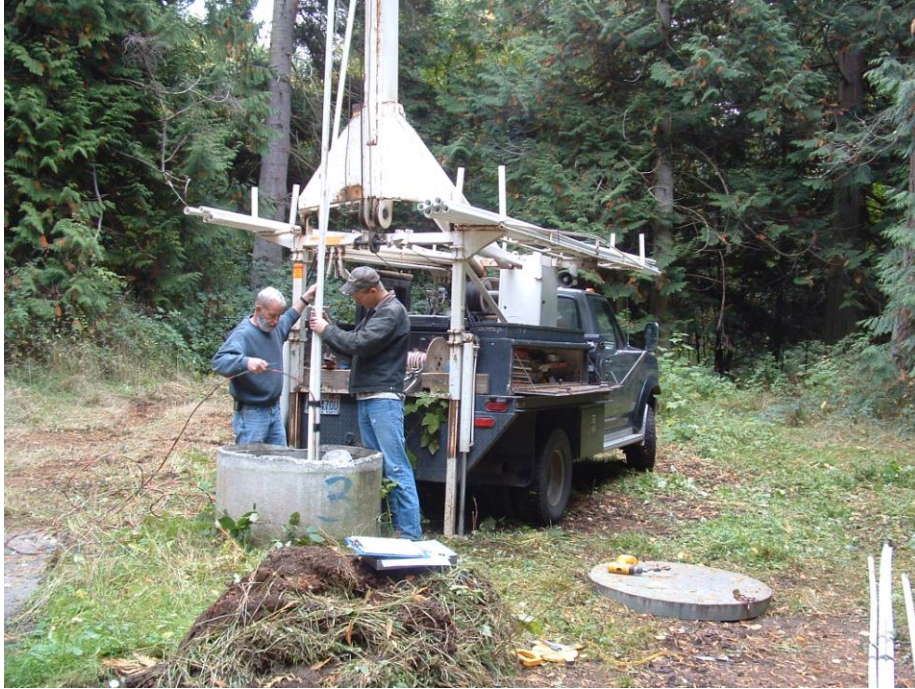
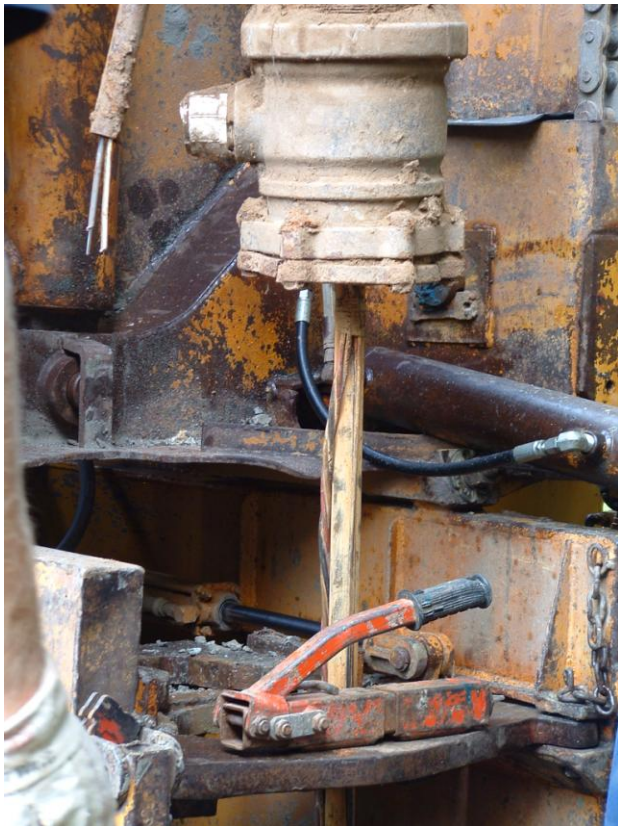
Figure 2. Removal of the pump and associated plumbing from a well (different wells). The lower picture shows a type of pitless adapter common to municipal water supply wells drilled on Reservation in the 1970s. The bottom of the pitless adapter connected below grade to the top of a six inch diameter casing and at the top to a seven inch diameter casing that extended to 1.85 ft. above the ground surface (Well No. 89 and similar to Well No. 128).

Figures 2 through 5 are pictures of the various steps of decommissioning a drilled well (they are not all pictures of the same well). Figure 6 illustrates a secondary seal.

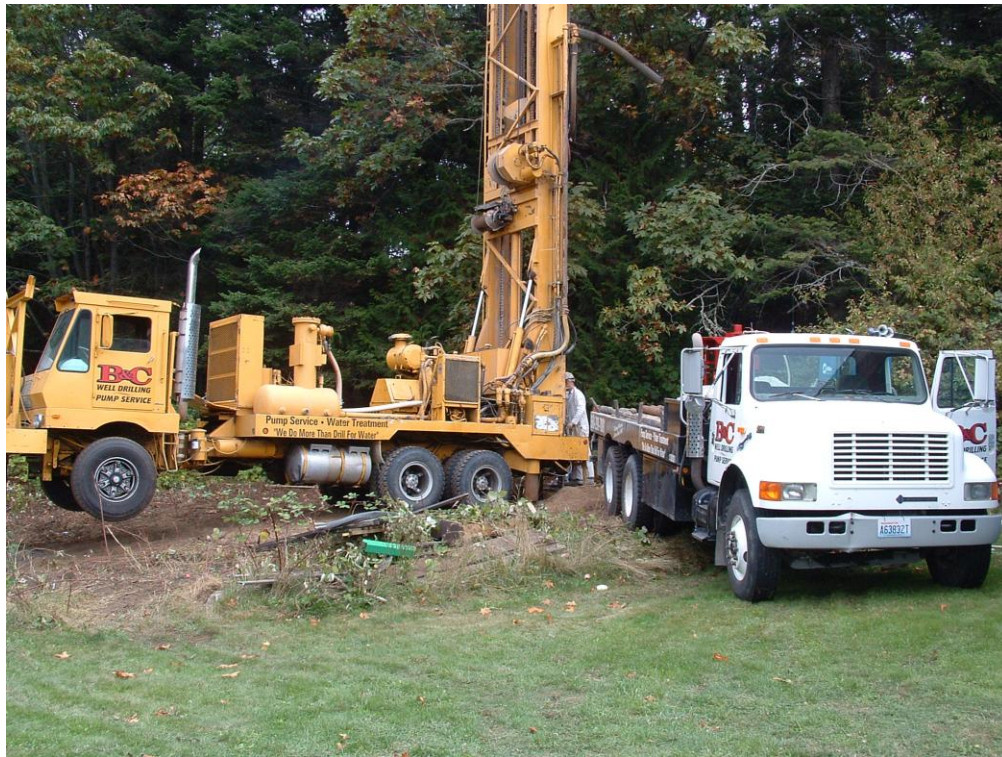
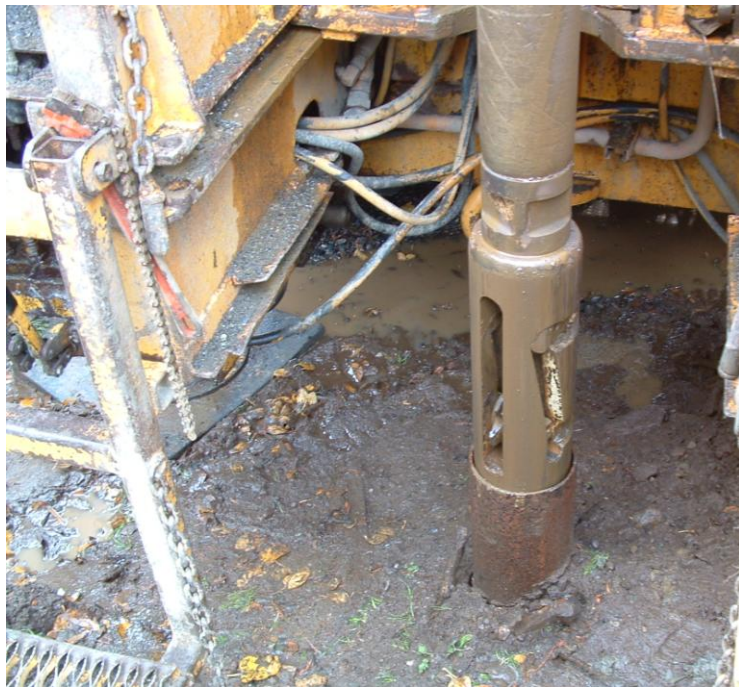
Figure 3. Well perforation operation shown in (a) and (b) shows the perforation tool (in different wells).

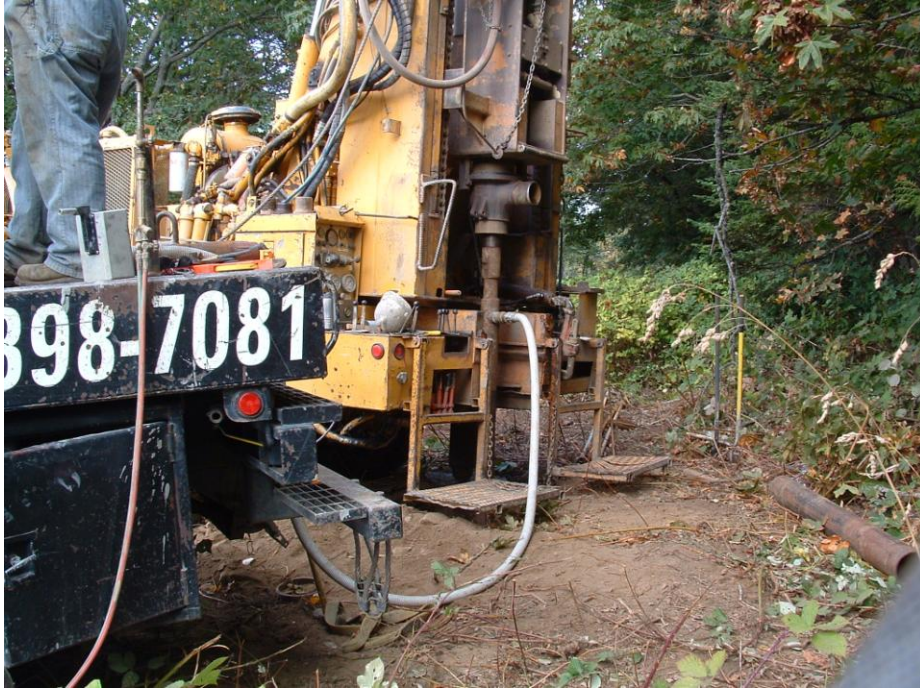
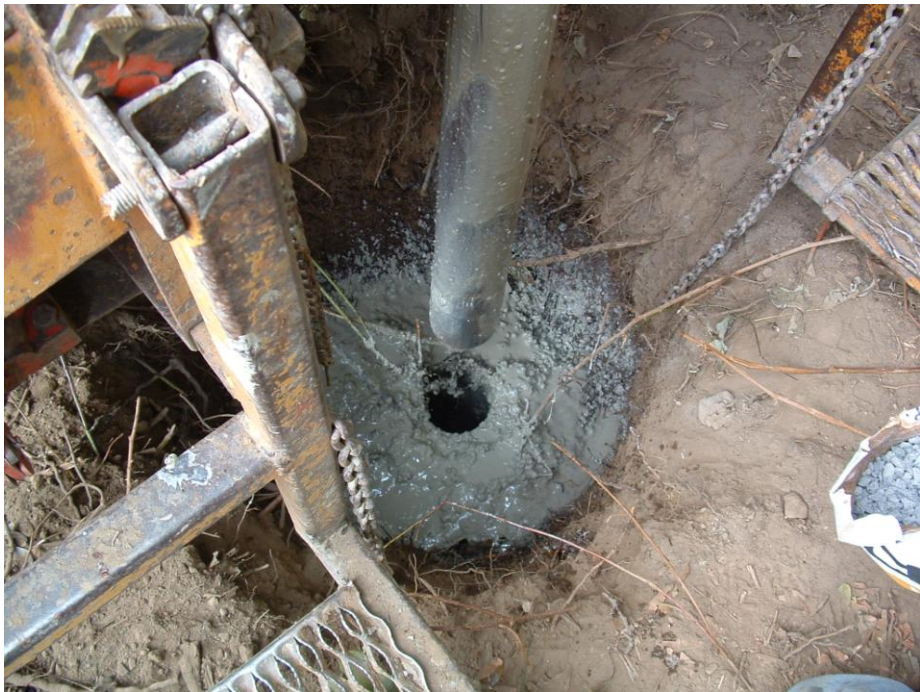
Figure 4. Placement of bentonite slurry. Photo (b) shows unhydrated bentonite chips placed around the top of the casing near the end of placement of bentonite slurry into the well. This was done to eliminate dirt filling of the annular space that is part of the secondary seal.

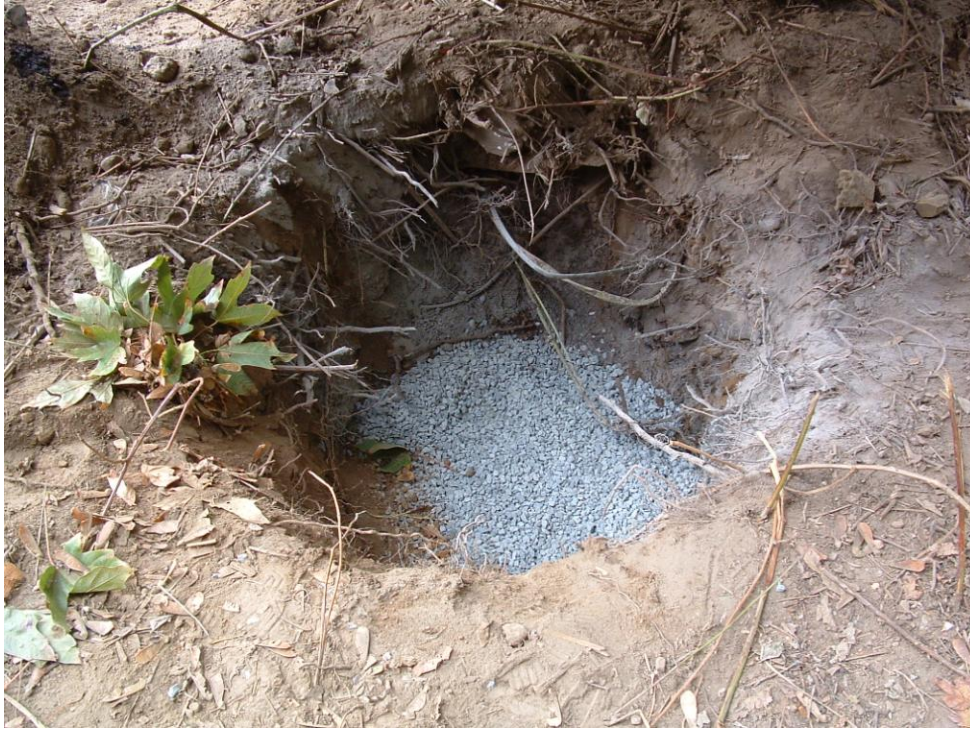
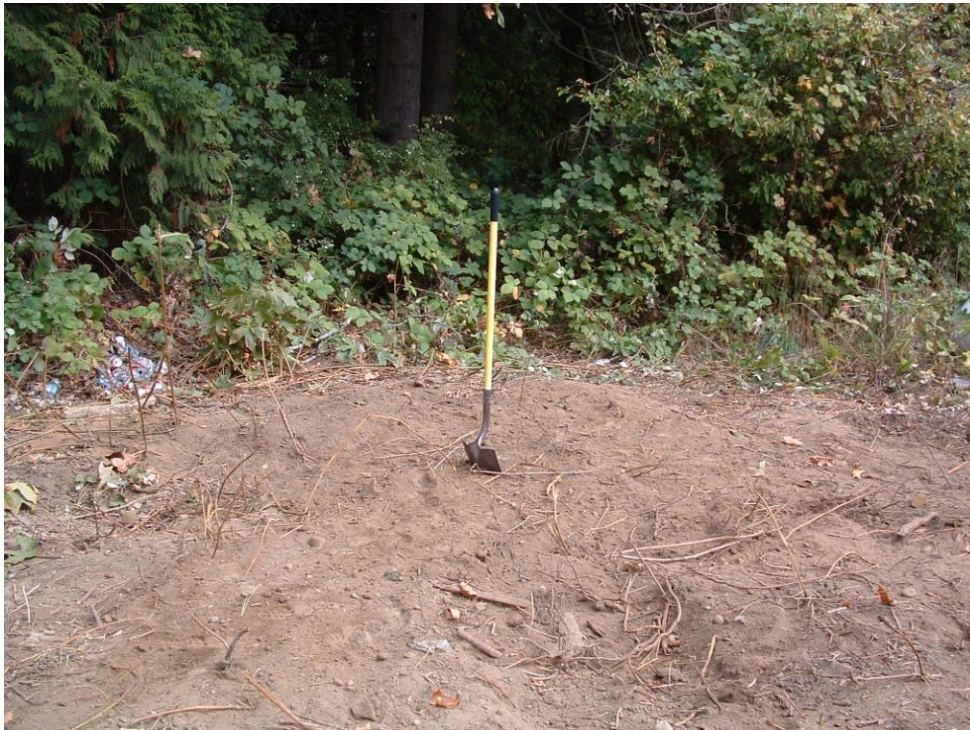
Figure 5. Burial and final grade of the decommissioned well. Completion of the secondary seal (a) and final grade (b) (shovel marks location of the decommissioned well).

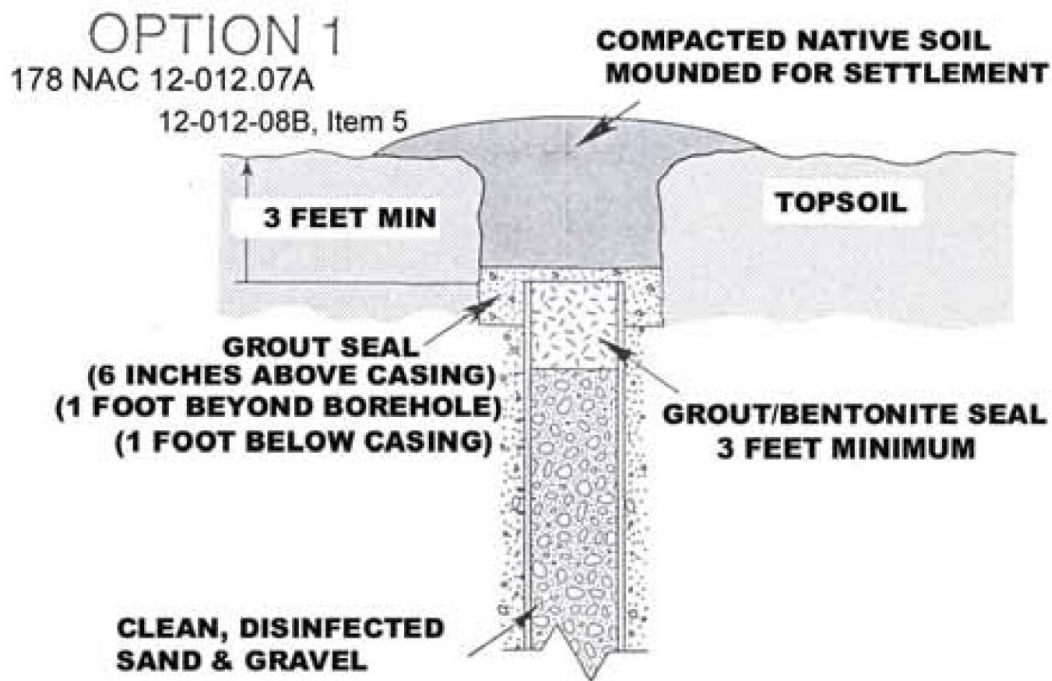
Figure 6. Illustration of secondary seal. The “Grout Seal” above is the ‘secondary seal’ that was utilized for well decommissioning (from Nebraska Health and Human Services, Title 178, Chapter 12, Figure 11).

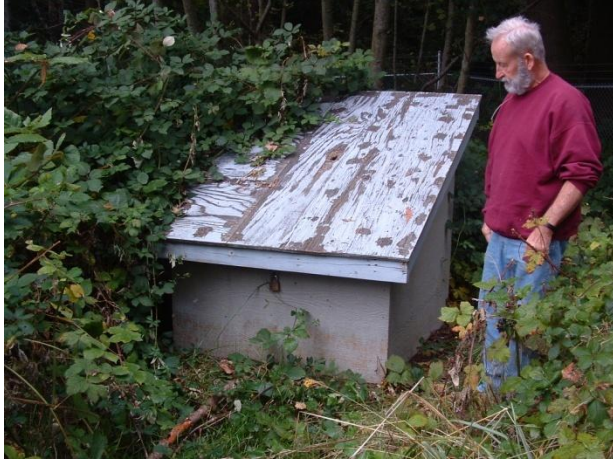
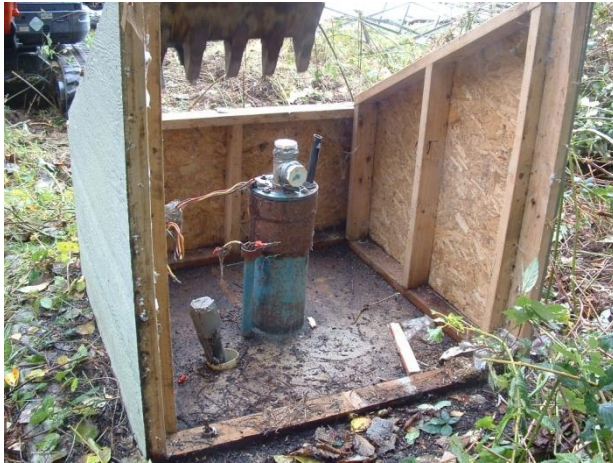
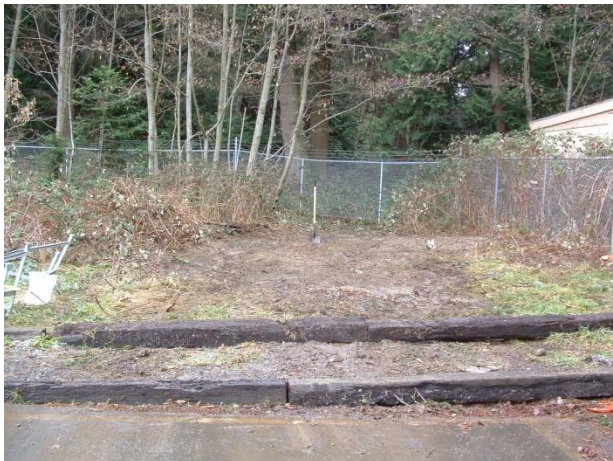
Well No. 128 was located in the Mackenzie neighborhood just north of, and above Gooseberry Point. The well was selected for decommissioning because it was abandoned and vulnerable to contamination due to its location in a residential area (Appendix A). The well was evaluated for decommissioning in 2009, but there were administrative issues that precluded the work occurring in 2009. The Well Decommissioning Report (Appendix B) documents the decommissioning of the well. Figure 8 shows the well before and after decommissioning.

No problems were encountered during the decommissioning of the Mackenzie I well. However, construction of the well, and subsequent modification in the late 1990s to allow the well to be instrumented with a datalogger resulted in additional time to perform the decommissioning¹.

Figure 8. Well No. 128 (Mackenzie 1) before decommissioning (a), during removal of the wellhouse (b), and after decommissioning (c). In (b), note the sleeve at the top of the well to accommodate plumbing through a sanitary seal instead of a pitless unit.

The small wellhouse and underlying concrete slab were demolished and removed from the site (the nearby fenced concrete block pumphouse was not addressed during this effort) on November 16, 2010. The next day, the pumpstring and access tube were removed and the wellhead sealed until work could resume. About two weeks later, a hole was dug around the wellhead to about 4 feet deep so that the casing-portion of the pitless unit could be removed to allow the perforator into the well. A temporary casing was then placed over the remaining casing (i.e., the casing below the pitless unit). The temporary casing had a sleeve that fit tightly over the remaining casing, and two, 50 lb bags of 3/8 inch unhydrated bentonite chips were placed outside and around the joint between the remaining and temporary casings, and the rest of the hole around the temporary casing refilled with the dirt that was removed when the hole was excavated. The temporary casing extended to 34-inches above the ground surface and the top was sealed. The next day the well was perforated from the bottom of the casing to the top (the temporary casing was not perforated). The perforation process resulted in the bottom 12.5 feet of the well filling with formation materials. Bentonite slurry (forty-two 50 lb bags) was then placed into the well from the bottom to near the top. The next morning the top of the bentonite slurry was 7 ft. below the ground surface. Bentonite slurry was then placed to the top of the temporary casing, the drillstem was then removed from the well, one bag of unhydrated chips placed into the well, and then the drillstem was used to push an 8-inch diameter plate and the underlying bentonite column down 18 feet into the well. The well was refilled to just below the ground surface, the temporary casing pulled, and six bags of unhydrated chips added to the remaining hole. Topsoil was placed over the bentonite, and grass seed was applied to the disturbed soils.

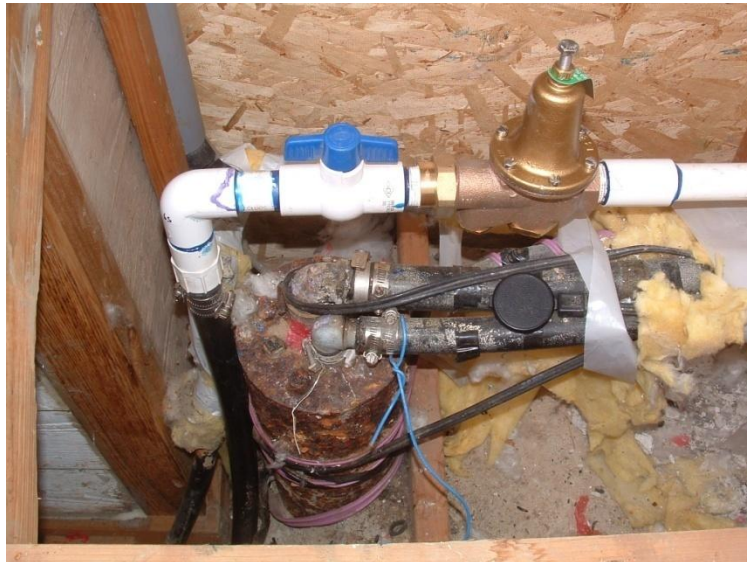
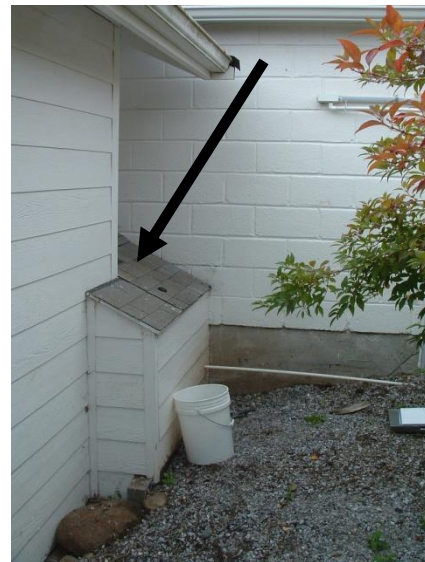
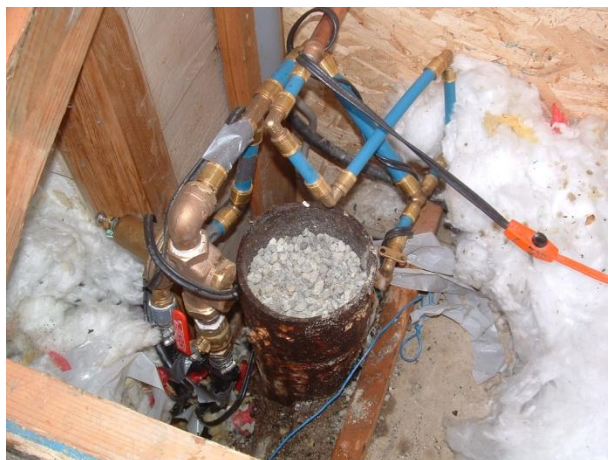
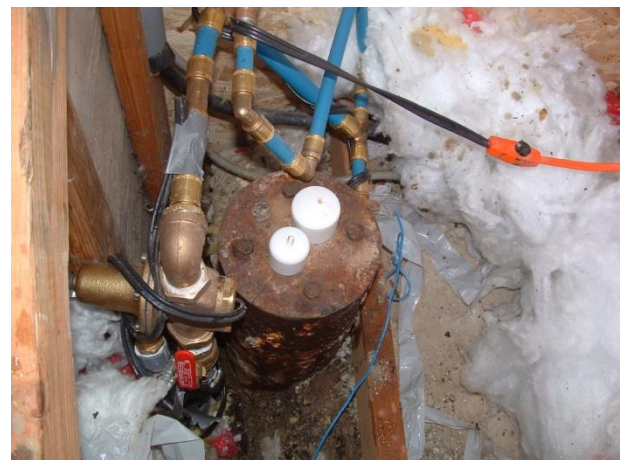
Well No. 175 is located immediately adjacent to the home at 2201 Lummi Shore Road in a residential shoreline development. The well is in a small enclosure attached to and between the house and the garage (Figure 9). Well No. 175 was decommissioned because it was abandoned and posed a contamination threat to ground water due to proximity to both the home and a marine shoreline (Appendix A). The Well Decommissioning Report (Appendix B) documents the decommissioning of the well. Figure 9 shows the well before and after decommissioning.

Poor access to the well prevented perforation of the well and placement of bentonite slurry from the bottom of the well. A secondary seal was not feasible due to proximity to the house foundation and incorporation with the garage foundation, as well as domestic plumbing in the immediate area of the well. Where the well entered the soil was dry during inspections and the work (Oct. to Dec.) and it appears that surface and roof drainage are diverted away from this area (the owner indicated that was the case, as there had been prior rot issues in that corner of the house).

Figure 9. Well No. 175 before (a) and after (b) decommissioning. In the upper right photo (a), the black arrow indicates the location of the well in the small structure attached to the house and garage.

No problems were encountered during the decommissioning. The pumpstring was removed, and the well filled with ten and one half, 50 lb bags of 3/8 inch unhydrated bentonite chips to within a few inches below the top of the casing. Excess water (estimated at 5 gallons) was removed with a pump to prevent flooding of the enclosure. The water was pumped into a 50 gallon drum and disposed of by B&C Well Drilling offsite. The sanitary seal was replaced at the top of the well casing, with two capped PVC pipes where the twin-tubes had been located.

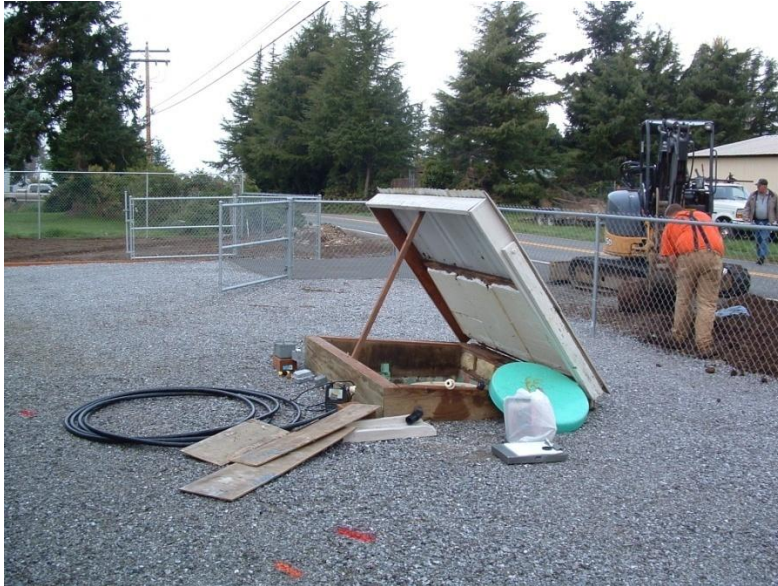
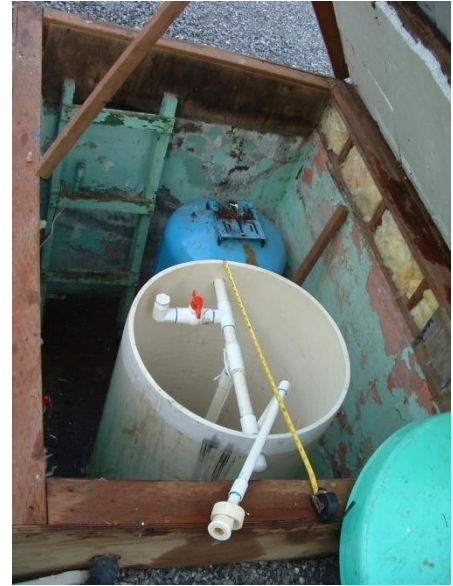
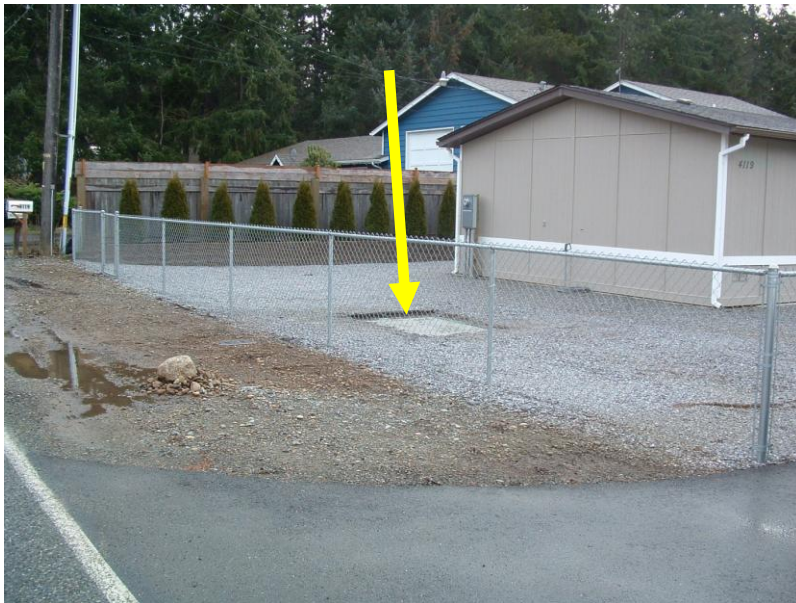
Well No. 651 is located at 4119 Germaine Road in a parking area near a home and close to Germaine Road. Well No. 651 was decommissioned because it was abandoned and vulnerable to contamination (Appendix A). The Well Decommissioning Report (Appendix B) documents the decommissioning of the well. Figure 10 shows the well before and after decommissioning.

Well No. 651 is located in a below-grade pumphouse and taps a water table aquifer. The water level in the well at the time of the planned decommissioning was above the floor of the pumphouse, and pumping the well at 40 gallons per minute (gpm) dropped the water level about one foot (below the bottom of the pumphouse) in mid-December.

Figure 10. Well No.651 pumphouse and well before (a) and after (b) decommissioning. The yellow arrow in (b) shows the location of the decommissioned well.

One week later, the water level had dropped due to cold and dry weather, and there was not water in the pumphouse. Fifty-five bags of 3/8 inch unhydrated bentonite chips were placed into the well. The top of the chips was about even with the floor of the pumphouse. No water was displaced from the well into the pumphouse during placement of the chips. The next day, 4 cubic yards of concrete was placed into the top of the well and the pumphouse, to within a few inches of the ground surface. The well owner is going to cover the concrete with gravel at a later date.
